Public Works

September, 1991

Restoring Atlanta's City Hall Corrects Design Flaws

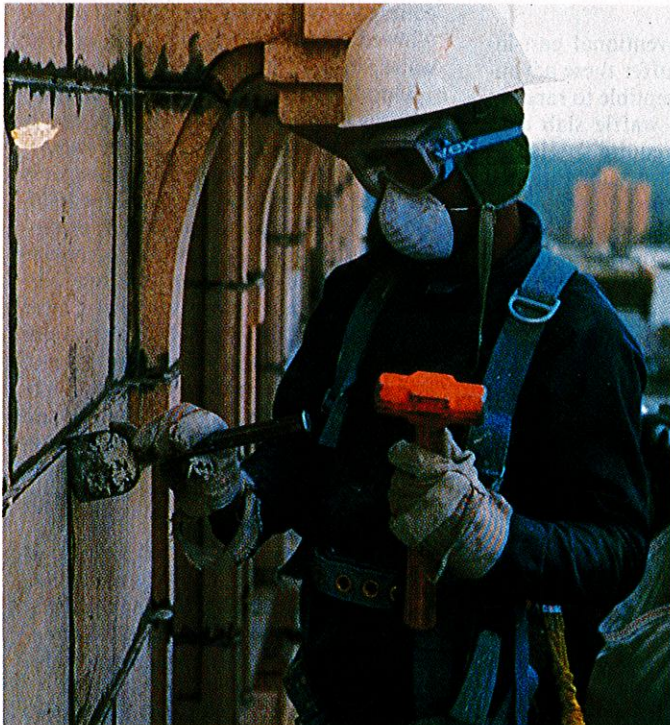
"None of the supports extended all the way to the building corners," noted Sven Thomasen, affiliated consultant with Wiss, Janney, Elstner Associates of Emeryville, California, engineers for the restoration project. "This caused vertical displacement cracks between the supported and unsupported sections. Some of these cracks extended through 15 stories—from the ground through the roof."

In turn, the cracks allowed significant amounts of moisture to enter the wall, corroding the shelf angles and terra cotta anchors and damaging the building interior. The rust build-up resulted in more cracking and bulging of the terra cotta. This was particularly evident at the toe of the shelf angles where the deformation of the wall caused instability and localized collapses.

Western drilled 55, 3-in. diameter cores to identify corroded steel support angles and anchors. At this point, the original contractor's omission of shelf angles at the building corners was discovered. Eventually, an additional 1,200 ft of ASTM 36 steel shelf angles were needed—nearly four times the amount originally estimated. Weepholes were also specified every 48 in. on center along the supporting angles.

■ MAJOR repairs were needed at the building's corners, where steel shelf angles had been omitted by the original contractor. Above, workman removes a damaged terra cotta cladding block.

Full-height expansion joints were cut into each corner and soft, Hypalon rubber strips were installed under the shelf angles at each floor. Built-up stress in the walls had reached an average of 300 psi. As the expansion joints relieved the stress, new cracks appeared on the lower floors and some ashlar virtually exploded as the strain was relieved.

high-strength polymer concrete (Silikal) as an economical substitute for replacing the terra cotta ashlar on the tower.

The final phase of the restoration involved repointing the entire building and infilling the expansion joints at the corners with two-part polyurethane sealant.
