WEATHER VANE

PUBLISHED BY THE WESTERN GROUP

Peterson Uncovers Uncharted Territory in State Capitol Building

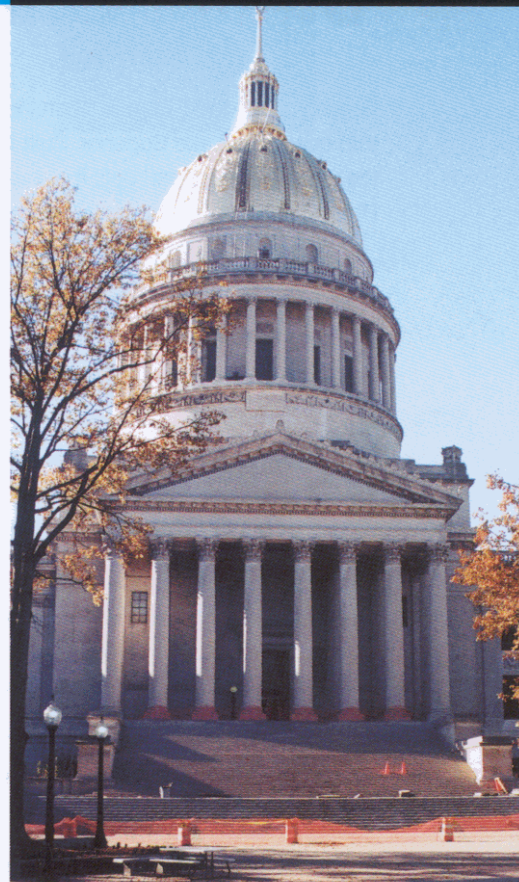
Left: Beneath the deteriorated slab, the Peterson crew discovered a 6 ft.-deep cavernous space that ran the length of the portico.

Center: The previous structural system was replaced with galvanized and stainless steel decking components.

Right: Limestone pavers were replaced with bricks, as specified in the original design by architect Cass Gilbert.

"The decay of the structural slab was much greater than anticipated," said Bill Kostelic, Pittsburgh branch manager. "Beneath the deteriorated slab, we found a cavernous space that was totally unexpected. It was six feet deep, ran the entire length of the portico and had huge five foot tall stalactites from moisture seepage."

The Peterson crew replaced the old structure with galvanized and stainless steel decking components, and installed a plumbed internal weep system. The system, which includes cross-ventilation and a vapor barrier, was designed by Carol Stevens for the state's General Services Administration to deter future deterioration due to moisture.

The original limestone pavers were replaced with bricks, which was the design originally envisioned by Cass Gilbert, the Capitol's architect. The new surface was installed with a waterproof Laticrete®-based system to further protect it from water intrusion. The project was completed in May 2002. ■

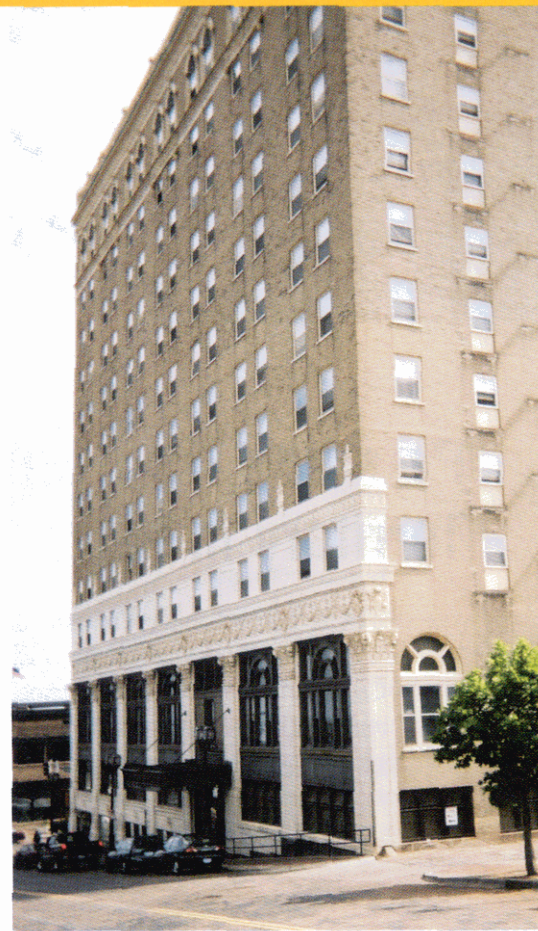
Above: Much of the terra cotta ornamentation on the nearly 80 year-old building was cracked, spalled or missing.

Western used cementitious materials to rebuild the damaged areas of the ornamental configurations. The crew applied the materials and then carved them to match existing pieces. Acrylic finishes and sponge painting were used to blend the color of the repairs with the original terra cotta.

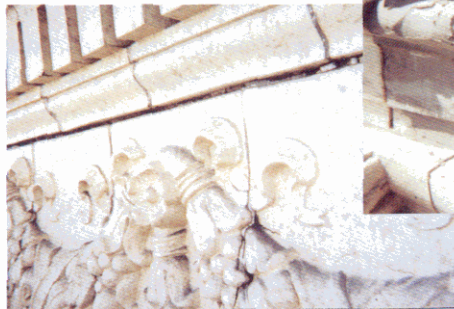
Left: Cementitious materials were used to rebuild damaged areas, then carved and painted to match the original terra cotta.

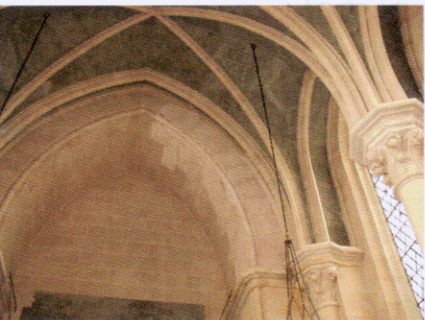
A large portion of the chapel's interior was resurfaced with Sonocrete® Gel Patch, a cost-effective solution that also improved the acoustics of the structure.

"We ended up applying Sonocrete® Gel Patch over the infills. We built it out about 1/16" and finished it with a smooth steel trowel," Curt Romberg, lead foreman, said. "The Gel Patch was a charcoal color and, with the existing material, gave the infill the look of veined black marble."

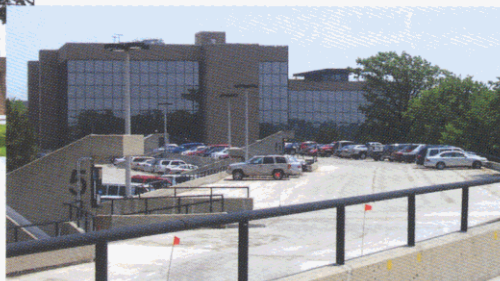
Top: Overhead, vertical and horizontal concrete repairs were carried out throughout the facility.

The Western crew performed overhead, vertical and horizontal concrete repair throughout the facility. Cracks that spanned the entire length of beams were structurally repaired using epoxy injection.

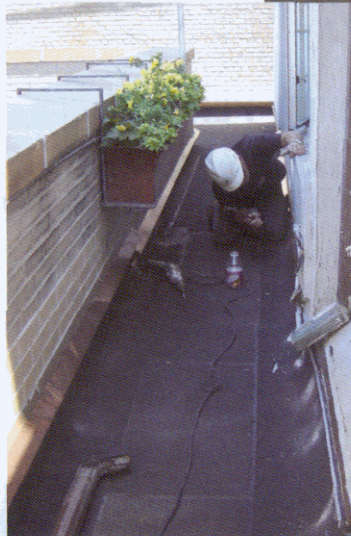
After removal of the reroofing piles and the original membrane, the Brisk crew installed a new, U.S. Intec roofing system.

The building's main roof had been replaced a number of times, with the reroofing plies installed over the original membrane. Testing showed the presence of asbestos fibers in the original roofing membrane. A licensed asbestos removal contractor stripped off and disposed of the original membrane after the Brisk crew had removed the other layers of material. Then a new, U.S. Intec roofing system was installed.

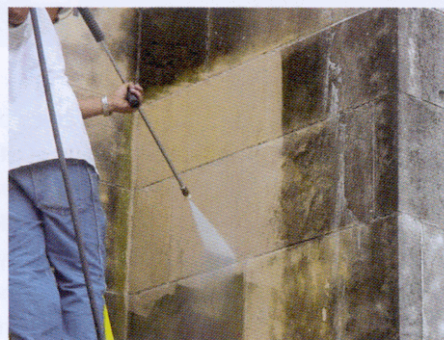
The bell tower of Trinity Episcopal Church required three cycles of cleaning in some areas to remove the staining from the limestone.

"We went through one cycle of cleaning, then another, and even a third one in some areas before we were able to remove all the staining," explained Charlie
