# WEATHERVANE

PUBLISHED BY THE WESTERN GROUP

## Reflection Pool Mirrors Expertise of Brisk's D.C. Branch

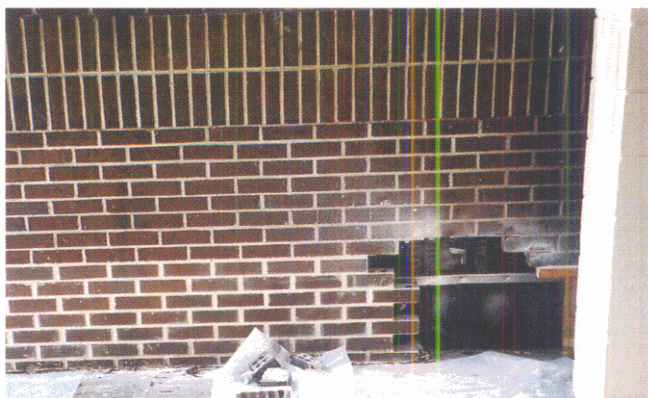
The architectural consulting firm, also located in Orlando, discovered that the structures had been built without through-wall flashing. Moisture condensed in the cavity between the brick building skin and the interior wall, and then pooled at the base of the wall, causing significant damage to the schools’ interiors.

After removing the bottom six courses of brick, Western replaced the wall sheathing and installed laminated through-wall flashing and stainless steel counter-flashing. More than 4,000 linear feet of flashing and 40,000 replacement bricks were used in the project.

In June 2003, Western’s Orlando branch began work to remedy the problem. Crews removed the bottom six courses of brick, replaced the wall sheathing and installed laminated through-wall flashing, as well as stainless steel counter-flashing. New brick, matched to the existing masonry, was used to reconstruct the exterior wall over the new flashing system. The crews also installed stainless steel caps and coated the block columns.

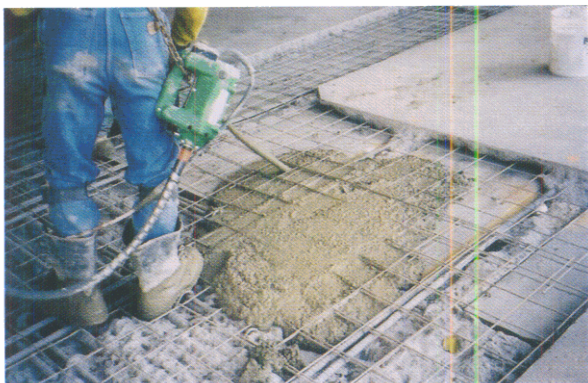
Built in 1965, the structure sustained significant concrete deterioration from freeze-thaw damage and exposure to road salts.

*An asphalt overlay masked the degree of damage to the garage, which required over 15,000 sq. ft. of full depth concrete repairs.*

Over the years, metal plates were used to cover the most severely damaged areas. Also, asphalt was laid over the concrete in an attempt to repair the surface. In the survey phase of the restoration project, the asphalt overlay complicated assessing the damage.

"It also undoubtedly contributed to the damage, by encapsulating the moisture and de-icing agents," he continued.

In all, the Western crew performed over 15,000 sq. ft. of full-depth slab repairs and patched 2,600 sq. ft. of vertical laminations. After concrete repairs were complete, a deck coating was applied to protect against water intrusion. The crew also painted the interior and installed new drains and lighting. The project was begun in July 2002 and completed in May 2003.

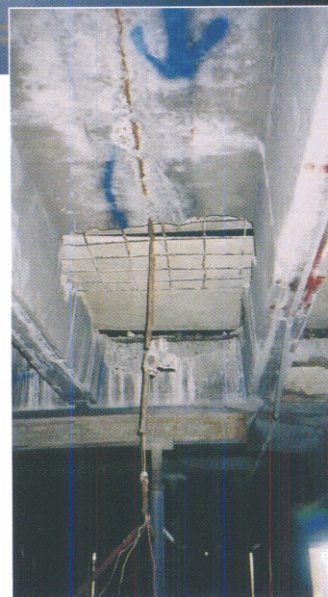
*Top: After extensive concrete repairs, a deck coating was applied. Western also painted the interior and installed new drains and lighting.*

*Bottom: Over 2,600 sq. ft. of vertical laminations were patched.*

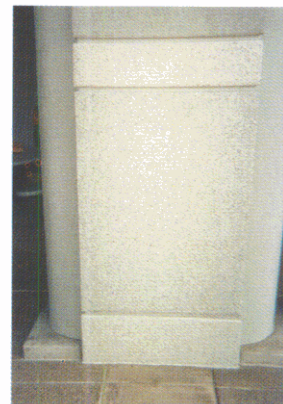
The Fashion Institute of Design and Merchandising (FIDM) is a private college located in downtown Los Angeles, adjacent to Grand Hope Park. Built in the late 1980s, the structure had been troubled by recurring leaks through its window perimeters and stucco exterior.

*Western recaulked and retrofitted window perimeters to address recurring leaks at the private Los Angeles college.*

Western recaulked the window perimeters and glass-to-metal joints and retrofitted the flashing at all window heads. In the process of making the repairs, the crew chipped out the stucco around the windows, installed new end dams and flashing, then patched and blended in the repaired areas.

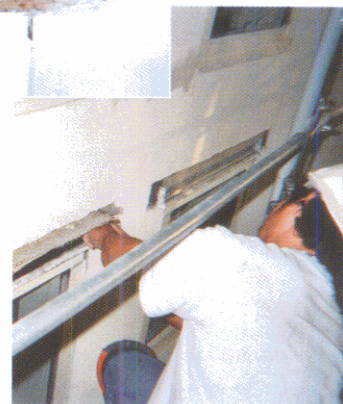
*The lower two stories of the building were coated with a water-borne urethane coating that gave the exterior the appearance of granite.*

Aesthetics also played a role in material selection for recoating the exterior of the structure. On the lower two stories, an elastomeric coating was used to give the exterior the look of granite. The water-borne-urethane material was specified by Wiss Janney Elstner Associates, architect for the project. The appearance of stone was achieved by carefully mixing colored chips into the coating at the job site.

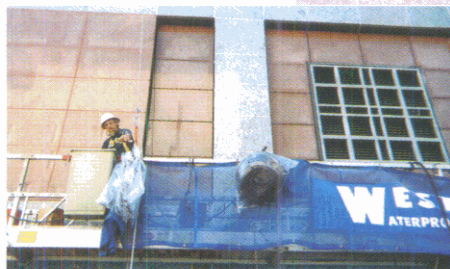
"The existing sealant around the windows had softened, and it was staining the granite," Tyler explained. "Our job was to completely seal the exterior façade and make it a closed system."

Western installed over 200,000 linear feet of sealant around the windows and exterior to seal the building façade.

In all, the Western crew installed over 200,000 linear feet of sealant. The project was completed in June 2004. ■

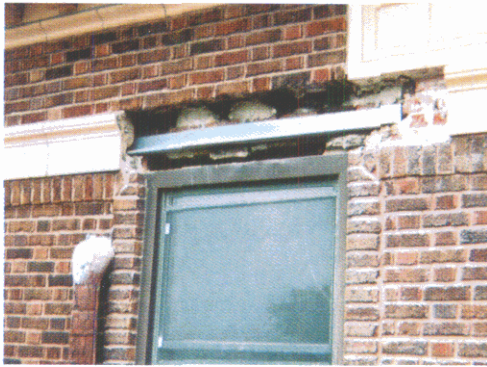
Cracked terra cotta pieces above windows were removed and replaced with cast stone replicas. The structural steel behind the masonry was repaired or replaced, and flashing was installed.

Recent work on the main structure involved repair and replacement of brick and stone, terra cotta, and lintel and structural steel components. Approximately 120 timeworn terra cotta pieces above the third and fourth-story windows were replaced. Cracked and deteriorated units were removed, molds made and new stones cast to match the existing in size and profile. By coating the new stones with an aliphatic urethane coating, the sheen and color of the original materials were closely matched. Concurrently, the structural steel behind the masonry was repaired or replaced as necessary, with areas flashed with a waterproofing membrane prior to stone installation.

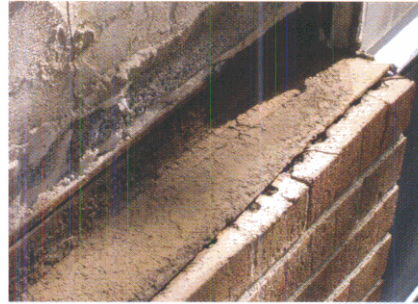
HSP traced the buckling brick to two factors. One was vertical growth of the veneer due to an absence of control joints at the relief angles. The brick facing had been built tight to the undersides of the steel shelf angles at each floor level. This induces pressure and stresses into the face brick. The second cause was the shearing of the header bricks connecting the building's two masonry wythes.

*HSP reanchored the face brick using a plate-and-anchor system. Because the back-up block was only 4" deep, 6" x 6" metal plates were added to stabilize the walls.*

The repair specifications called for reanchoring the face brick using a plate-and-anchor system. However, as workers drilled into the brick to install the five-eighths inch stainless rod critical to the solution, the wall grew increasingly unstable.

"What we found was that the back-up block was only four inches," Sanders adds. The decision was made to add six-by-six metal plates, but the cost to the client remained the same. "I told them others may say they can do it for less," he continues, "but we would not nickel-and-dime them."
