BEST OF

WEATHER VANE

Rochester Revels in Plummer Building Restoration

Western Addresses Unexpected at Eight Sixteen Club Condos

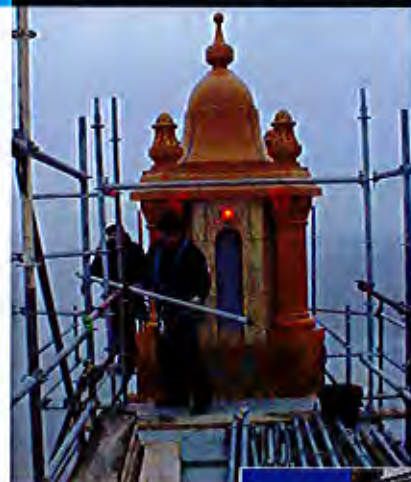
More than 400 replacement pieces of terra cotta were crafted using molds made to match the originals. Removal of damaged terra cotta allowed the first structural inspection in 75 years.

At the same time, samples of terra cotta were removed and shipped to Boston Valley Terra Cotta where molds were made and replacement pieces — more than 400, in all — crafted to match the original. The removal of terra cotta

also allowed inspection and repair of the building's steel structure for the first time in three-quarters of a century.

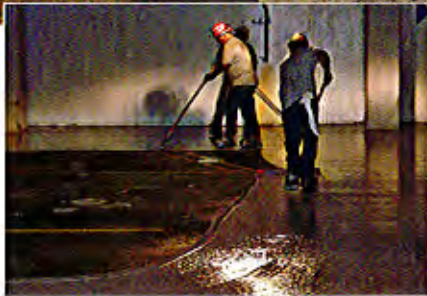
Harry S. Peterson Company did it by the numbers: installing 180,000 square-feet of urethane deck coating, maintaining 24/7 facility operation, achieving 100% client satisfaction.

In this case, that expertise was evidenced in an eight-phase plan, a seven-person crew and a schedule that called for coating installation on weekends only. The HSP team met all deadlines, including working over the Memorial Day weekend, to install the 180,000 square-feet of Lymlal urethane deck coating.

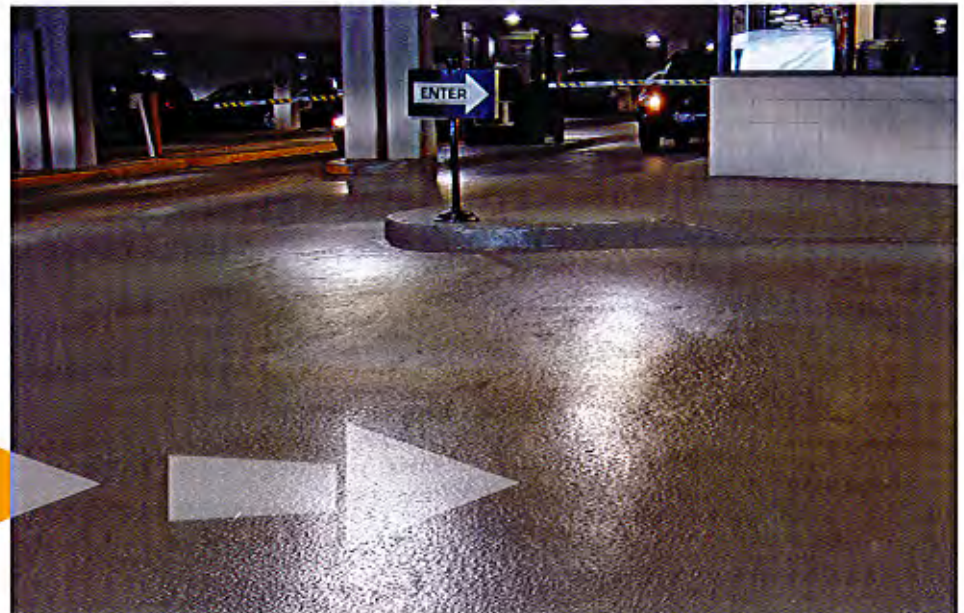
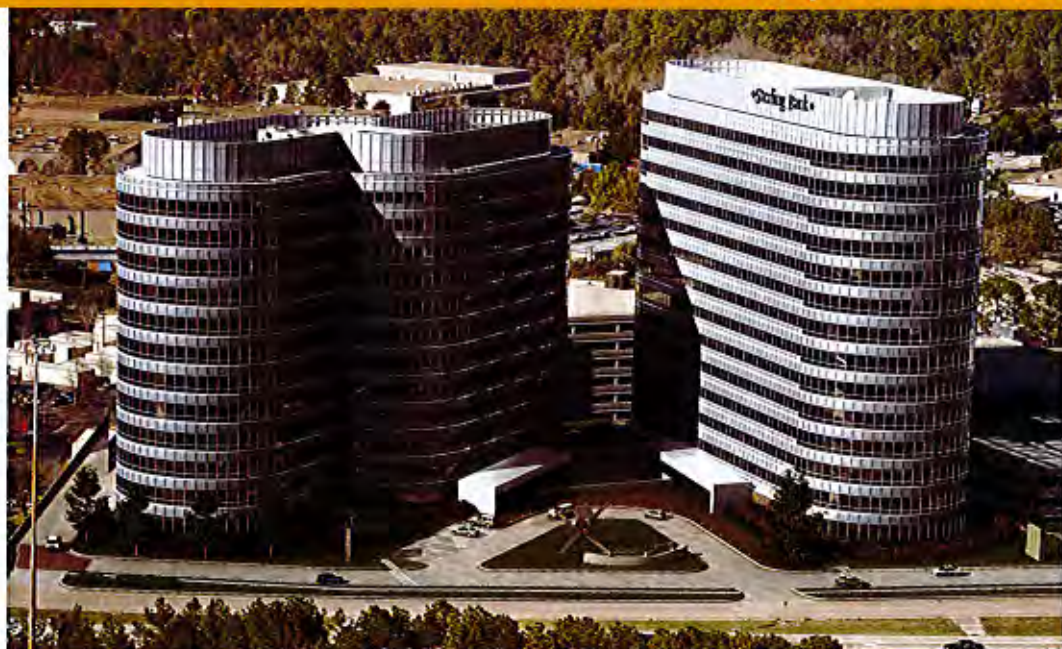
Close collaboration among Thomas Properties Group, Engineering Diagnostics and Western yielded positive structural and aesthetic returns for Brookhollow II and III. A striking silver and glass theme transformed the 1970s complex into a 21st century beauty.

Western crews overclad broken and cracked metal spandrel panels and installed custom-color preformed seals over the curtain wall butt joints. Panels and windows in the wall system were wet-sealed, snap covers replaced and aluminum covers installed at the accent band joints. Then came the paint—the choice of which had been decided in a Houston downpour with Thomas Properties' team members sheltered by Western umbrellas.

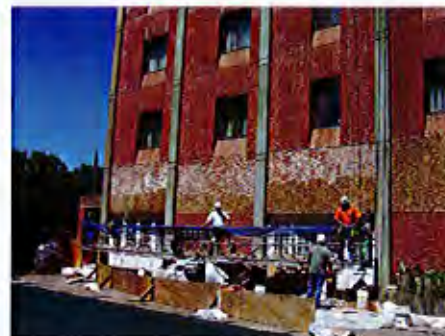
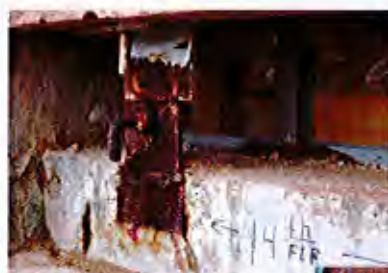
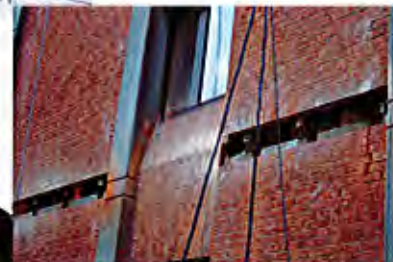
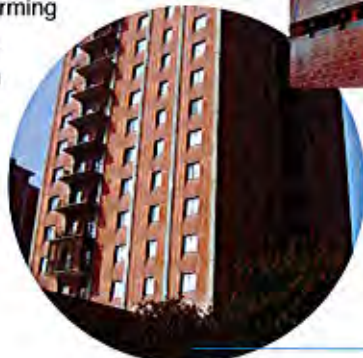
Heideman's examination revealed that age and exposure to the elements had caused deterioration of the structure's steel clips and shelf angles. The firm also determined anchors had corroded due to a chemical reaction with the Sarabond design. Without rapid repair, the integrity of the building was at risk. Western was tapped for the more extensive restoration.

Engineers traced structural problems at the Eight Sixteen Club Condos to two sources: general deterioration caused by age and elements and chemical reactions between anchors and the Sarabond design. Western removed failed components; installed new angles, clips or galvanized shelf angles; then replaced and sealed exterior brick.

Repairing the Eight Sixteen Club required the removal of existing brick to expose failing angles and clips and installing new angles, clips or galvanized shelf angles in their place. New brick was then installed and sealant applied at the vertical joints.
