Public Works

September, 1991

Restoring Atlanta's City Hall Corrects Design Flaws

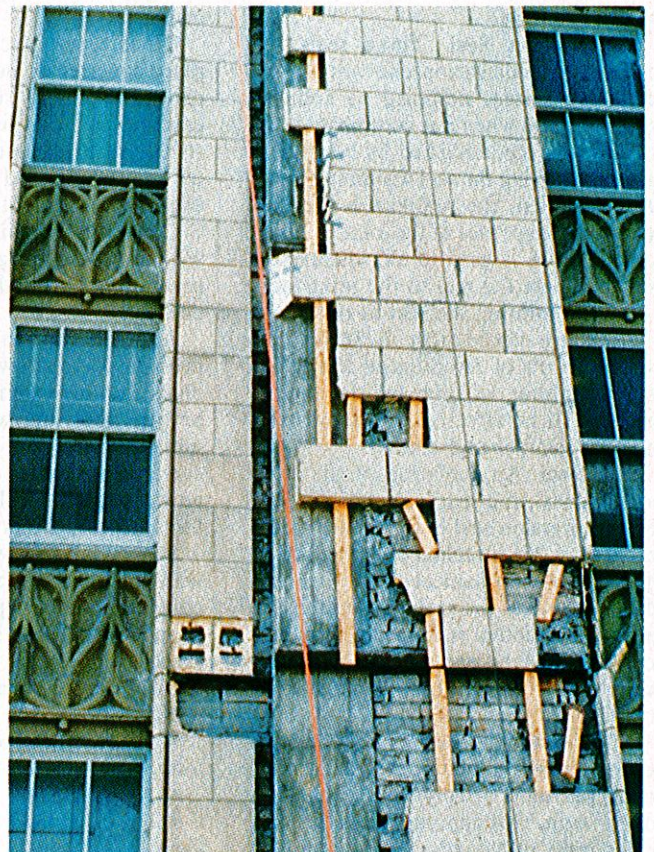
"None of the supports extended all the way to the building corners," noted Sven Thomasen, affiliated consultant with Wiss, Janney, Elstner Associates of Emeryville, California, engineers for the restoration project. "This caused vertical displacement cracks between the supported and unsupported sections. Some of these cracks extended through 15 stories—from the ground through the roof."

In turn, the cracks allowed significant amounts of moisture to enter the wall, corroding the shelf angles and terra cotta anchors and damaging the building interior. The rust build-up resulted in more cracking and bulging of the terra cotta. This was particularly evident at the toe of the shelf angles where the deformation of the wall caused instability and localized collapses.

■ MAJOR repairs were needed at the building's corners, where steel shelf angles had been omitted by the original contractor. Above, workman removes a damaged terra cotta cladding block.

Full-height expansion joints were cut into each corner and soft, Hypalon rubber strips were installed under the shelf angles at each floor. Built-up stress in the walls had reached an average of 300 psi. As the expansion joints relieved the stress, new cracks appeared on the lower floors and some ashlar virtually exploded as the strain was relieved.

Western drilled 55, 3-in. diameter cores to identify corroded steel support angles and anchors. At this point, the original contractor's omission of shelf angles at the building corners was discovered. Eventually, an additional 1,200 ft of ASTM 36 steel shelf angles were needed—nearly four times the amount originally estimated. Weepholes were also specified every 48 in. on center along the supporting angles.
