WEATHER VANE

Published by
WESTERN CONSTRUCTION GROUP

Austin's Historic Littlefield Restoration Merits Western Expertise

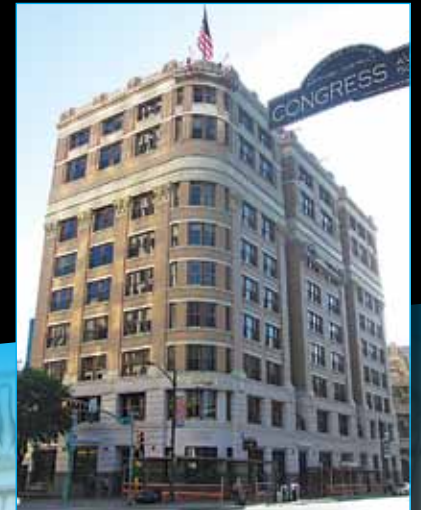
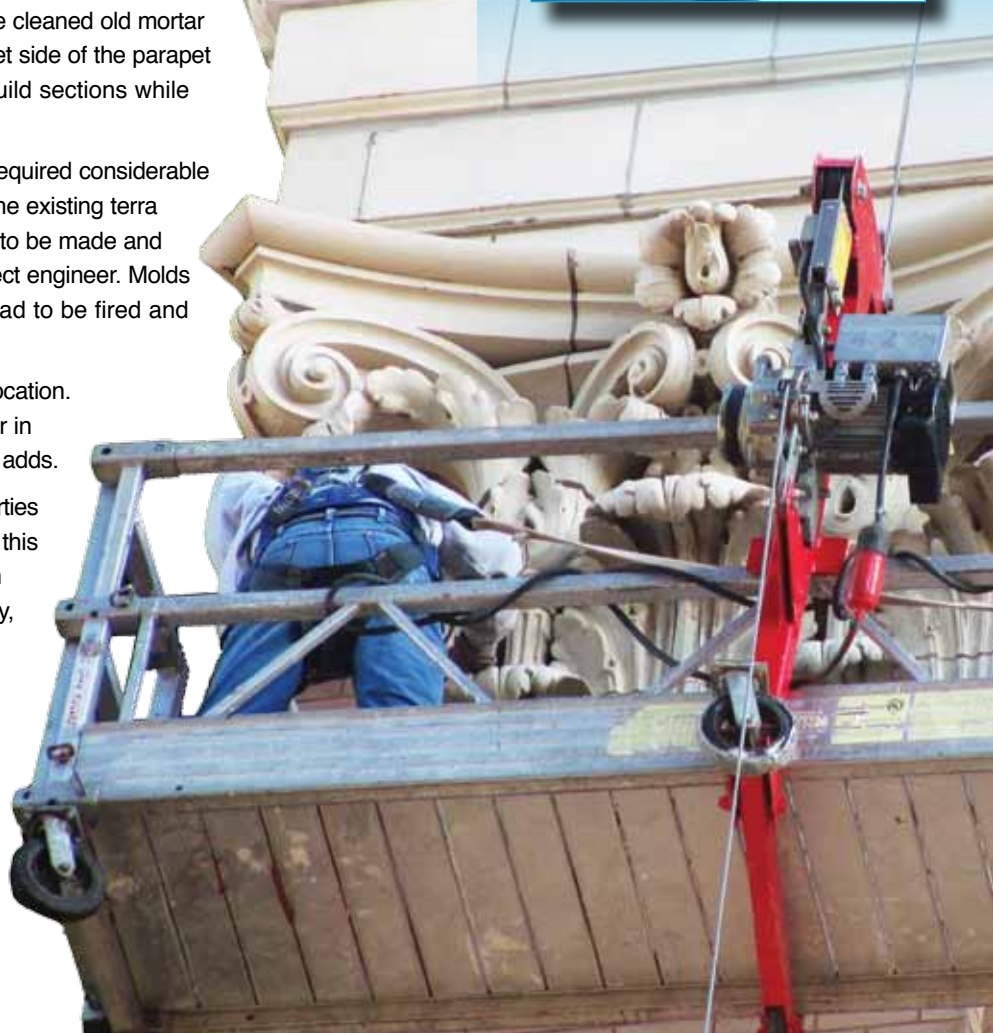
In spring 2012, Western's Dallas and San Antonio branches will jointly complete an extensive restoration of the Littlefield's exterior, repairing time-damaged brick surfaces and parapet wall terra cotta.

"In order to access the terra cotta," Western manager Dan Wicht begins, "we had to tear down and rebuild the brick columns. We cleaned old mortar from some of the existing brick and used it on the street side of the parapet wall, then used the good pieces of terra cotta to rebuild sections while waiting for replacement pieces to be manufactured."

The replacement process for the decorative masonry required considerable time and talent, Wicht continues. "We had to remove the existing terra cotta and ship it off for fabrication. Shop drawings had to be made and approved by Walker Restoration Consultants, the project engineer. Molds of different pieces had to be constructed, products had to be fired and glazed—then they could be shipped to the jobsite."

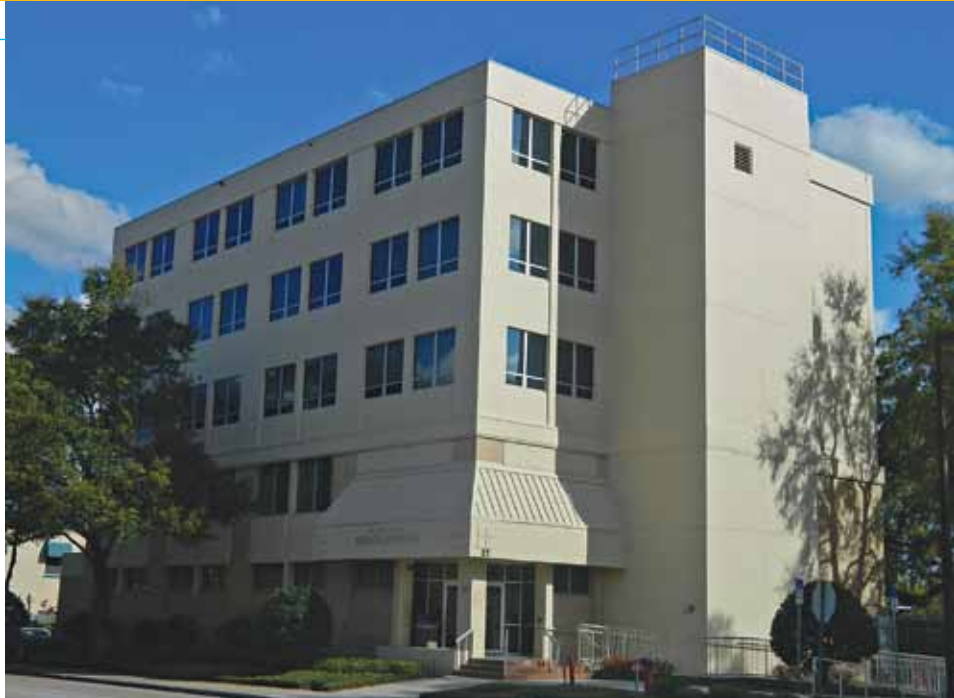
“The building had experienced serious water infiltration,” confirms Western branch manager Chester Scott. “Our scope of work included removing the failed stucco, replacing sealants and applying Tremco waterproofing to the full exterior of the building. Destructive testing was not conducted prior to our beginning work, however, and our crews realized early in the process that deterioration was more severe than had been anticipated. The budgeted quantity—1,500 square feet—was on target, but there were areas with damage and corroded lath four inches deep, and our specified patch repair was just half that.”

regarding the enlarged scope. Scott continues, “We were able to replace the entire lath in the repair areas and 100 percent of the stucco. Sealant replacement and Tremco waterproofing then proceeded according to the original plan.”

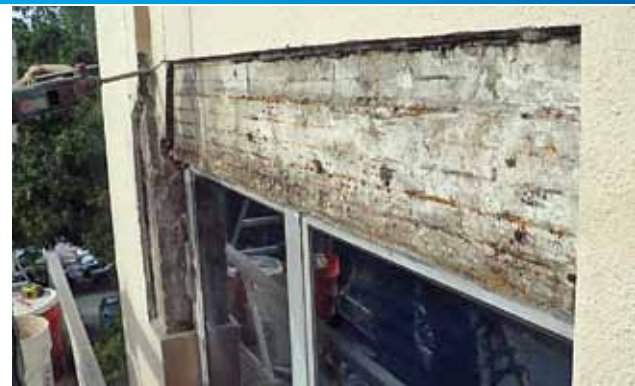
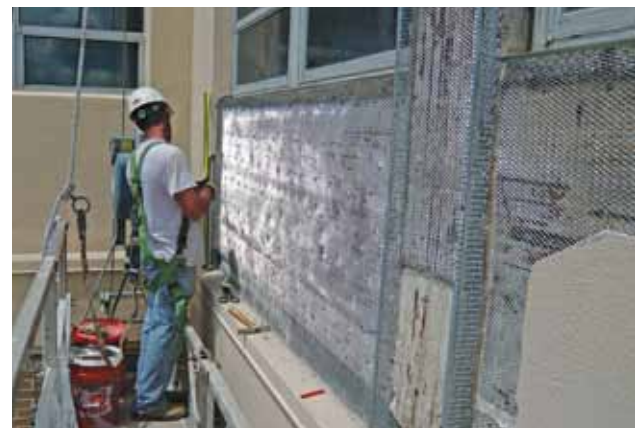
The scope of the 32 West Gore project increased significantly when Western discovered lath deterioration four inches deep—twice that originally anticipated. Swing-stage work requirements and ongoing tenant/guest access made safety a primary consideration. Both the finished project and Western process earned Orlando Health praise.

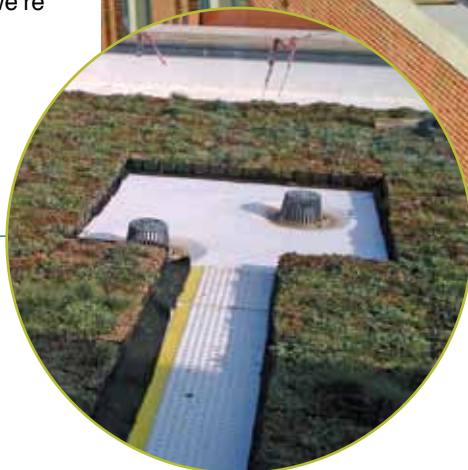
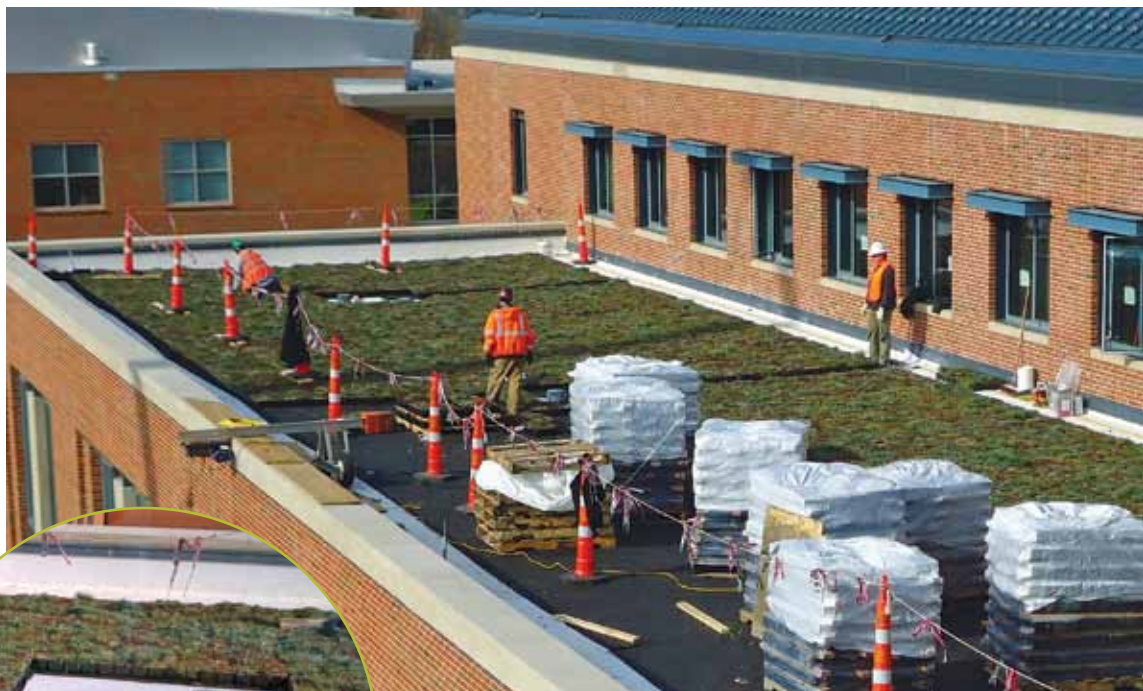
A total of 1,600 vegetation trays, each two-foot square, were secured to the two green sectors to create the lushly landscaped roof. Fully adhered TPO membrane was applied to the entire roof, with tapered insulation affixed to the non-green sector.

The overall roof design called for two green sectors and a third traditional surface. Each of the green areas received a base layer of fully adhered TPO membrane, to which some 1,600 vegetation trays—each 24-by-24 inches—were secured. The remaining roof system included fully-adhered TPO membrane adhered to tapered insulation.

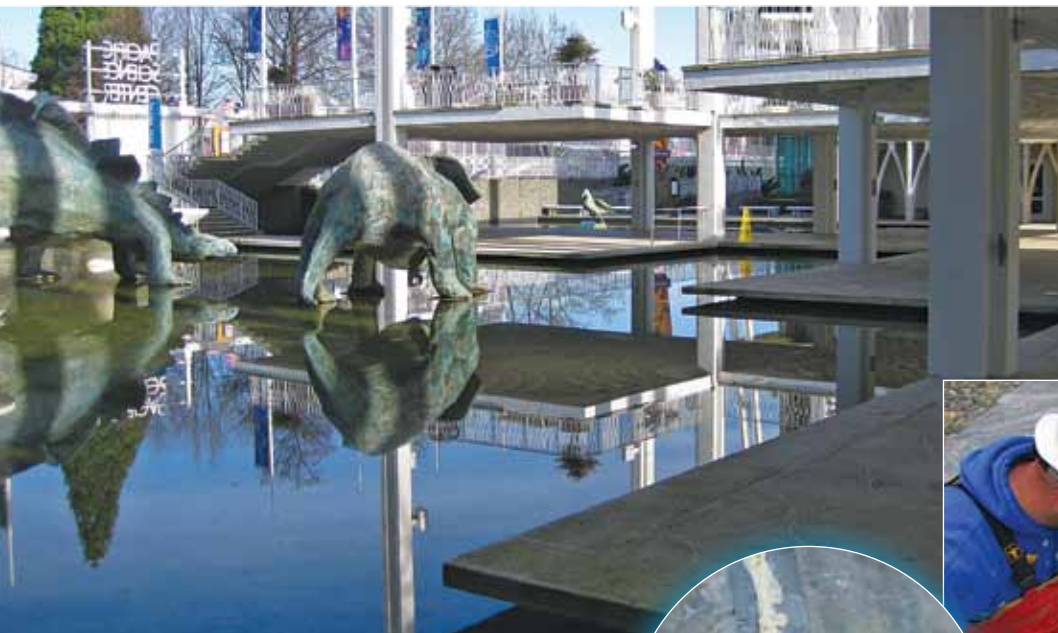
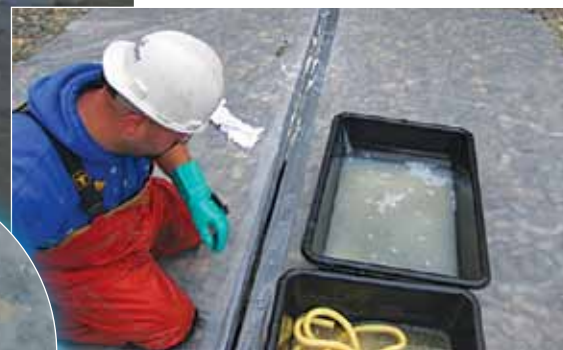
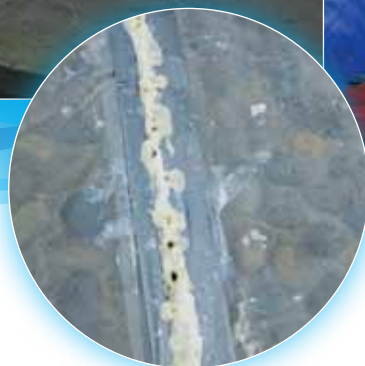
With Western’s innovative solution, water loss at the iconic ponds dropped from 55,000 gallons per day to virtually zero.

When Western’s Seattle branch was contracted to find a solution, a new strategy was devised. Branch manager David Kimble explains, “We developed a scope that included removing the deteriorating wood expansion joints, then installing a chemical grout in the

open joints as a primary seal. We then installed a secondary, sanded caulk joint at the top for aesthetic purposes.

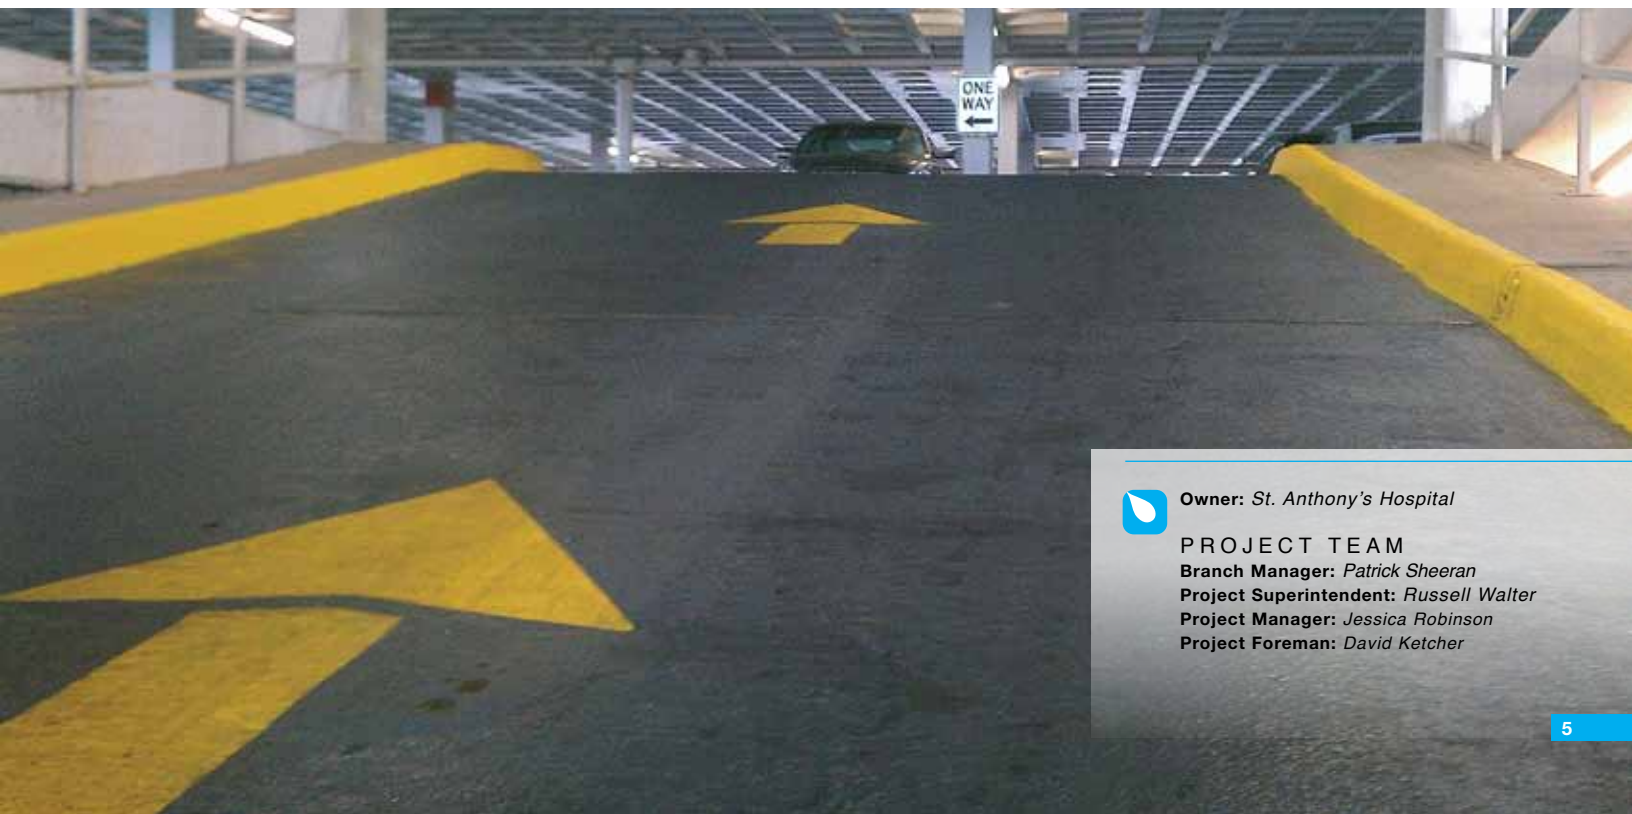
When the site is
St. Anthony Hospital's
West Garage in
Oklahoma
City.

One of two garages serving the 615-bed downtown facility, the attached 500-stall West Garage is open around the clock to serve hospital patients, guests and staff. The combination of high traffic, constant service and Oklahoma weather extremes had left its mark on this primary parking structure. Western's Tulsa branch was contracted to perform miscellaneous concrete repairs on 3,000 square feet of the garage's ascending and descending ramps. Also included in the scope of work was replacement of expansion joints and installation of 11,000 square feet of a traffic membrane capable of meeting those exceptional demands.

Because Western crews were only allowed to remove whatever concrete could be replaced in a single night, consistent progress during that 6 p.m./6 a.m. time slot was critical. "We did all the up ramps first, which meant temporarily changing directional usage of the down ramps. That we did through signage and well-placed personnel. Then we reversed it," Sheeran said. Rapid-set material kept repairs on schedule.

A Western crew of six to eight worked on the project from late September through December. They completed the concrete repairs before winter conditions upped the ante. "We did have to wait for some better weather to complete the coating," Sheeran adds, "then we had traffic control personnel there 20 hours a day until it dried." The three-layer deck coating employed was the new BASF Conipur traffic membrane.

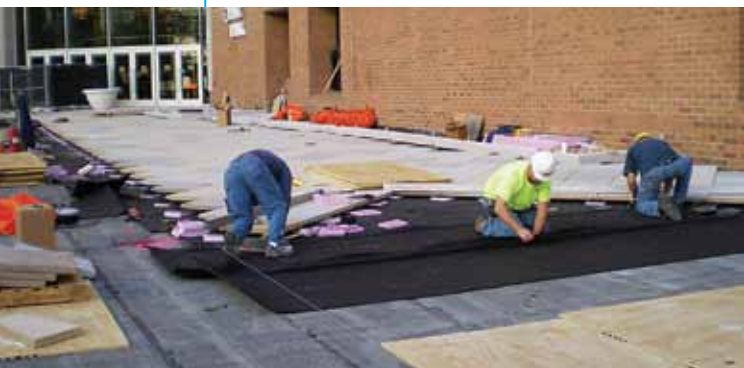
“Our scope of work included demolition of the existing concrete planters and topping slab, down to the structural deck,” Berndt continues.

“After repairing the concrete, we installed a hot-applied waterproofing membrane system and installed new topside finishes, including an open joint paver system. High-end handrails, a new pedestrian bridge linking the plaza deck to the Washington Street sidewalk, and the green landscaping rounded out the project.”

Western crews helped transform the PNC Center’s deteriorating all-concrete plaza into an inviting oasis of hardscape and landscape. REIT Management reports receiving “nothing but positive feedback” from tenants and Indy city officials.

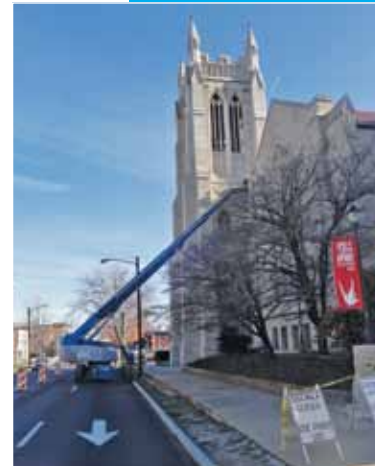
At 102 feet, the bell tower of the First Christian Church presented access challenges for Western crews tasked with repairing the tower's stone mullions.

The project scope was extensive, Rehtin confirms. "We were contracted to tuckpoint 100 percent of the mortar joints, and to remove and replace all sealants at the capstones, windows and door frames. There was spalled limestone in need of patching, and we had to repair the stone mullions on the bell tower openings and stained glass windows, which rise 22 and 36 feet high."
