# The Recladding Remedy

Unchecked and overlooked envelope issues require severe solutions

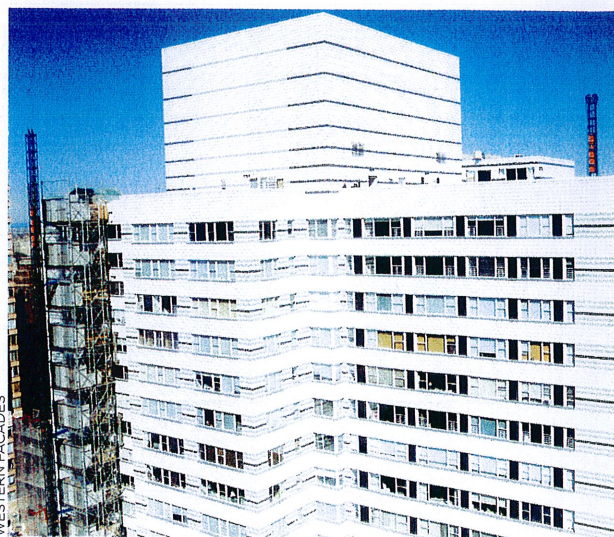
**This New York rental property recently underwent recladding. Its former facade had so much water infiltration that the glazed white brick faces popped off. The retrofit improves aesthetics and performance.**

Western Facades recently completed full-scale replacement of a facade on a New York rental property. The former system was glazed white brick that had so much water infiltration, some faces of the bricks popped off.

The solution entailed an air cavity, new insulation, and terra cotta rainscreen. Savings will be realized through the efficient barrier and because the system requires less maintenance and repair than traditional masonry.
